# Sound Analysis Report on the Comparison of the Schneider Violin Bridge to that of a hand carved and tuned Maple Bridge of Standard design and shape. By: Dennis Boring 04/2012

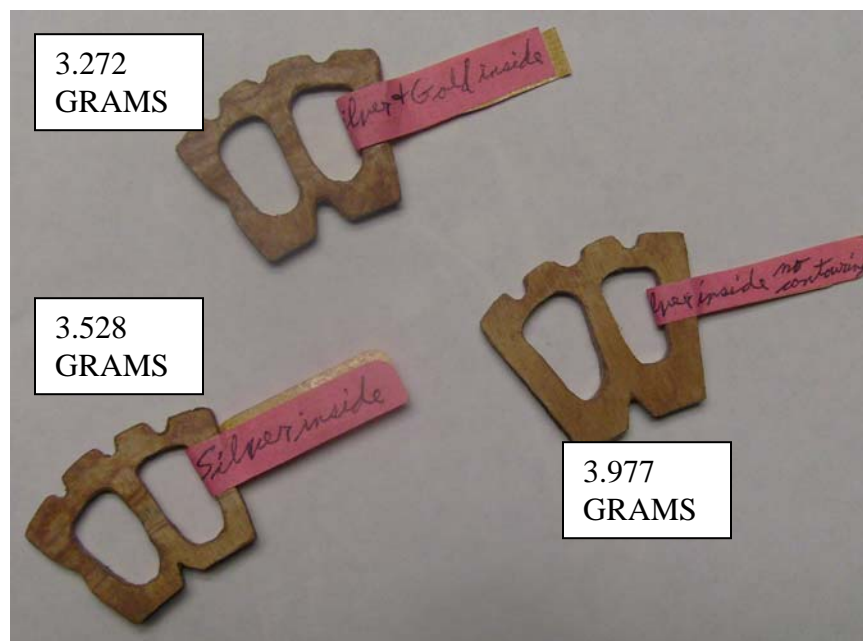
At first thought you would expect the silver/gold combination to weigh slightly more than either of the other two, but that was not the case, which makes me question the metallic composition of any of the bridges in the picture below. But given the ‘rough’ finishing done on all three, I am not surprised after examining them more closely.

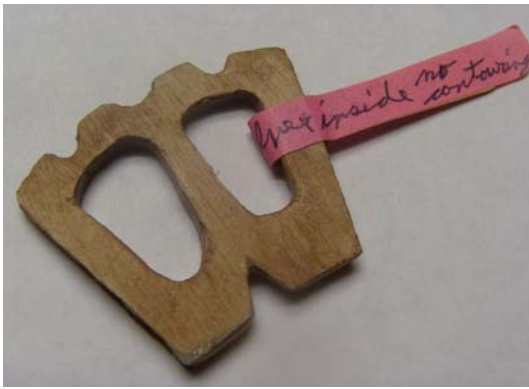
Before trimming

In an attempt to fit the one bridge that came tagged with handwritten words saying, “silver inside no contouring” I was needing to reduce the overall height of the bridge to somewhere close to my existing maple bridge since I require E string height of 3.5mm and a G string height of 5.5mm. In order to follow the instructions and ONLY remove material on the feet, I would’ve ended up with no bridge at all, having needed to cut up into the opening of the center. So... in an honest effort to give this bridge a fair analysis, I cut on the top as well, keeping the shape as sent to me but using a carbide burr and deepening the depressions between the strings and sanding the top of the bridge as required to lower the strings to a distance closer to what I needed. Although I was reluctant to cut anymore off the bridge, I was able to get my strings down to a height of 4mm and 6mm respectively.

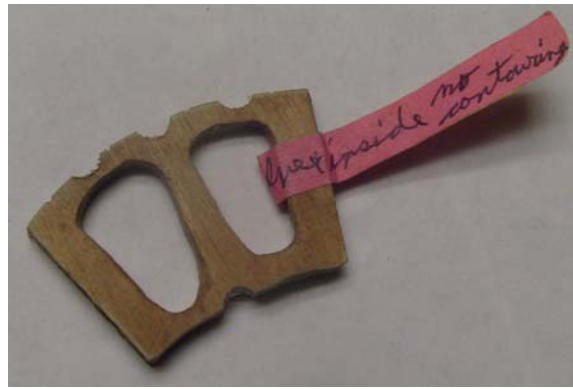
After trimming

Although it is obvious this would have affected the mechanics of sound transmission, there would be no other way to install this bridge so it had to be done. In an attempt to install it in the same location of my existing bridge, I attempted to 'swing' it up into position and deeply scratched the surface of the body from the harsh metallic content within the laminate. After removing the bridge I was able to refinish the affected areas with a combination of the 'French polish' procedure and a tiny bit of oil varnish diluted with 180 proof alcohol AND will wait about 3 days for it to cure before final polishing and reinstalling of my original maple bridge. The instructions said the end user should mix up some epoxy, spread it on the bottom of the feet and allow it to cure, then shape it to fit... etc. which is a complex job even for a luthier to accomplish and would add to the already high cost of the product making it prohibitive for most customers to even consider, and besides, the bridge was too tall already, and adding anything would make it too tall to even function properly.

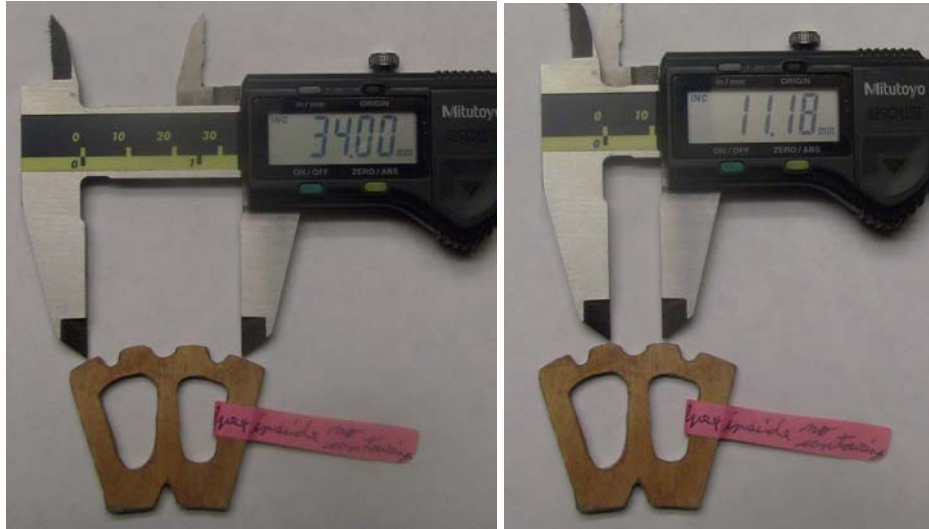
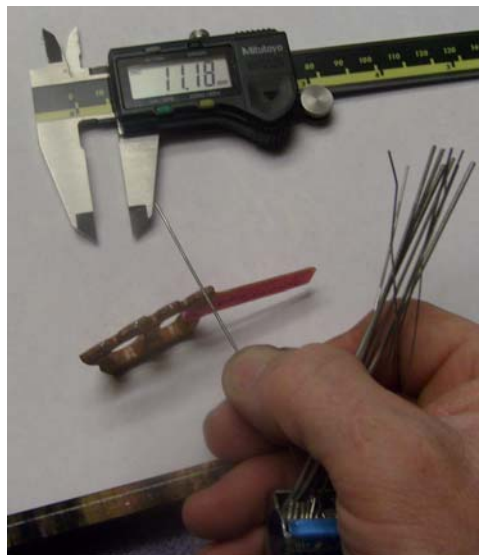
The string spacing for my violin is referenced as 34 mm outside and 11.18 mm between strings, which I was able to achieve with a little juggling. As you can see from the left side picture, the 34 mm spacing center of string to center of string would be near the edges of the top surface to the separation cutouts and if that centered measurement was held, the between strings dimension would very close to the center cutout. In order to keep the strings from falling off, it was necessary to slightly file (using a tiny round luthier file set for bridge work grooving) the top of the bridge. This was extremely difficult since luthier files are made of aluminum for cutting maple wood and not a metal laminate! I think I will need to buy a new set after this analysis work is done. These are ruined. It is apparent from the pictures the inconsistent openings of the bridge, but perhaps the inventor has determined that this difference is required to achieve the magic result although they don't have the same shape on the other two bridges provided.

The filing was done to a minimum depth to just hold the string vs. the standard  $\frac{1}{2}$  string diameter depth of normal bridge tuning and design. Although there was a substantial metallic core to this bridge I still installed the sleeve over the E string as it pass over the bridge to keep the test results valid as it was also installed on top of the wood bridge.

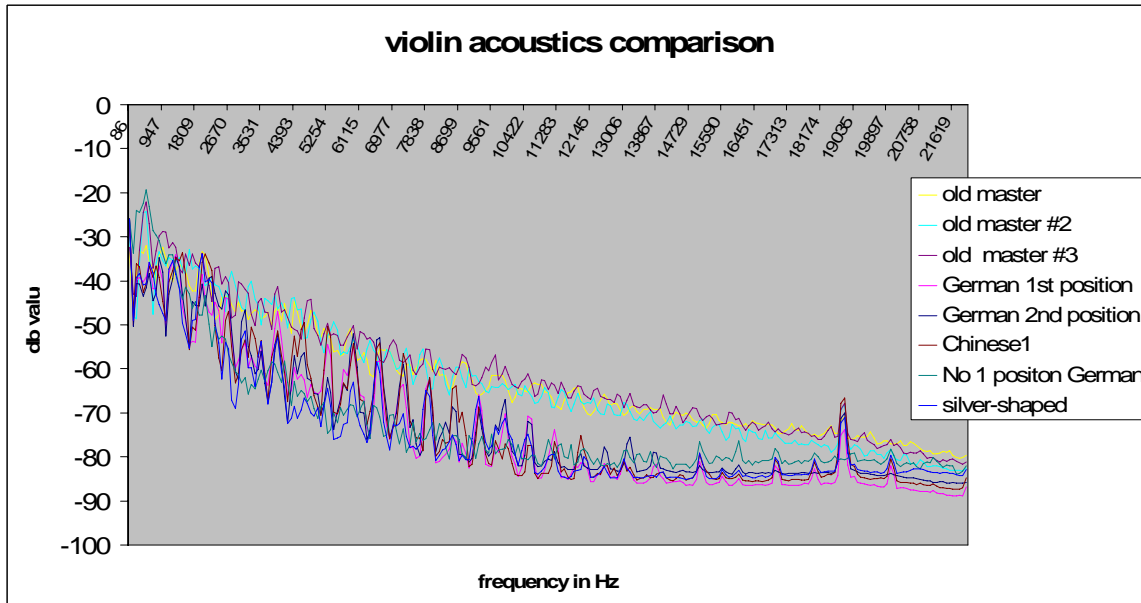
This chart was developed from hours of testing and sound analysis. The “old master” traces (the top three on the legend as well as the chart) are 1920 German violins demanding a price tag of \$18,500 to \$20,000 in range. As can be seen below those three traces, several of the others are mixed in. The bright pink trace named “German 1<sup>st</sup> position” is my violin (90 yr old German production instrument only valued at \$650) as it was originally set up by a luthier with a ‘good ear’. The remaining traces all show the various performance curves as labeled. The Chinese violin was a student model approx 10 yrs old with original metal strings installed as a comparison trace.

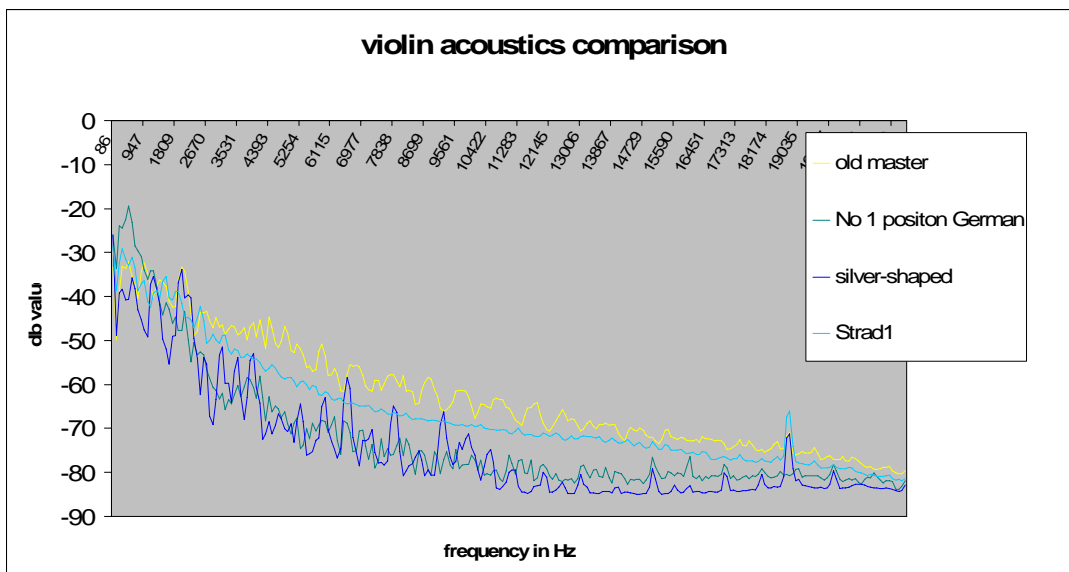
Below is a sound analysis from a true Strad (\$3.2 mil) violin. Notice the smooth light blue trace! The finest violin isn’t the one that is the lowest db reading from analysis, but that of the one with the least variation from frequency to frequency, and the Schneider Bridge does nothing to achieve that at any level of db performance.

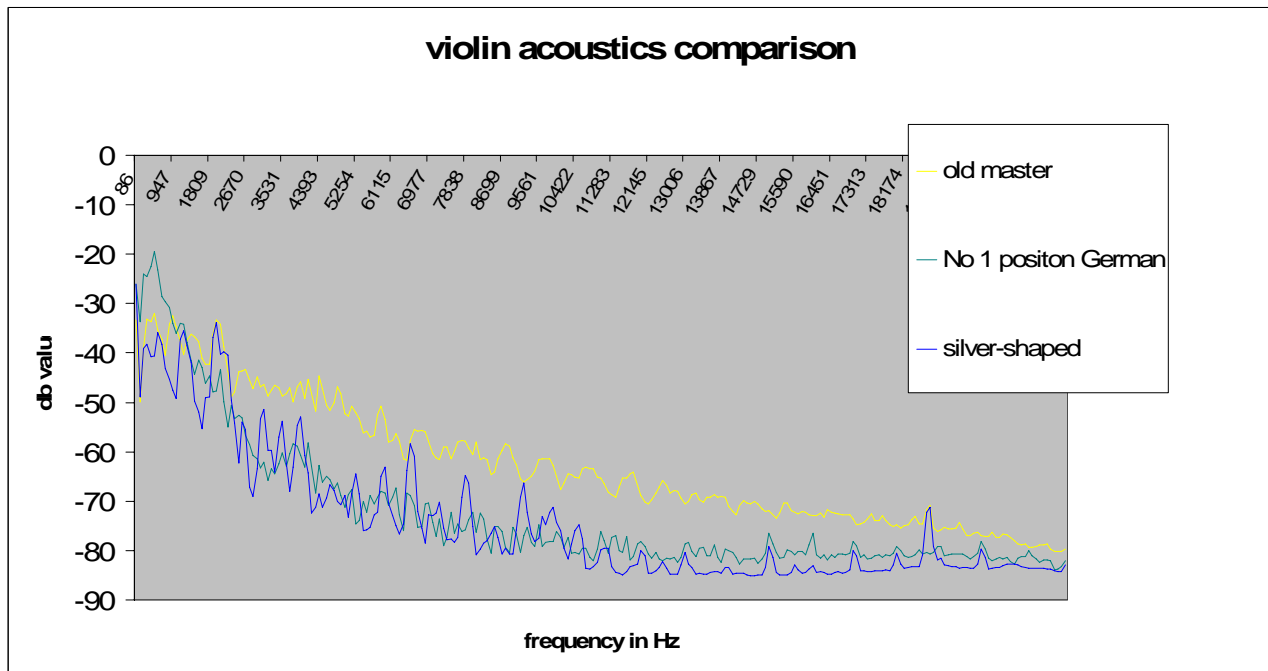
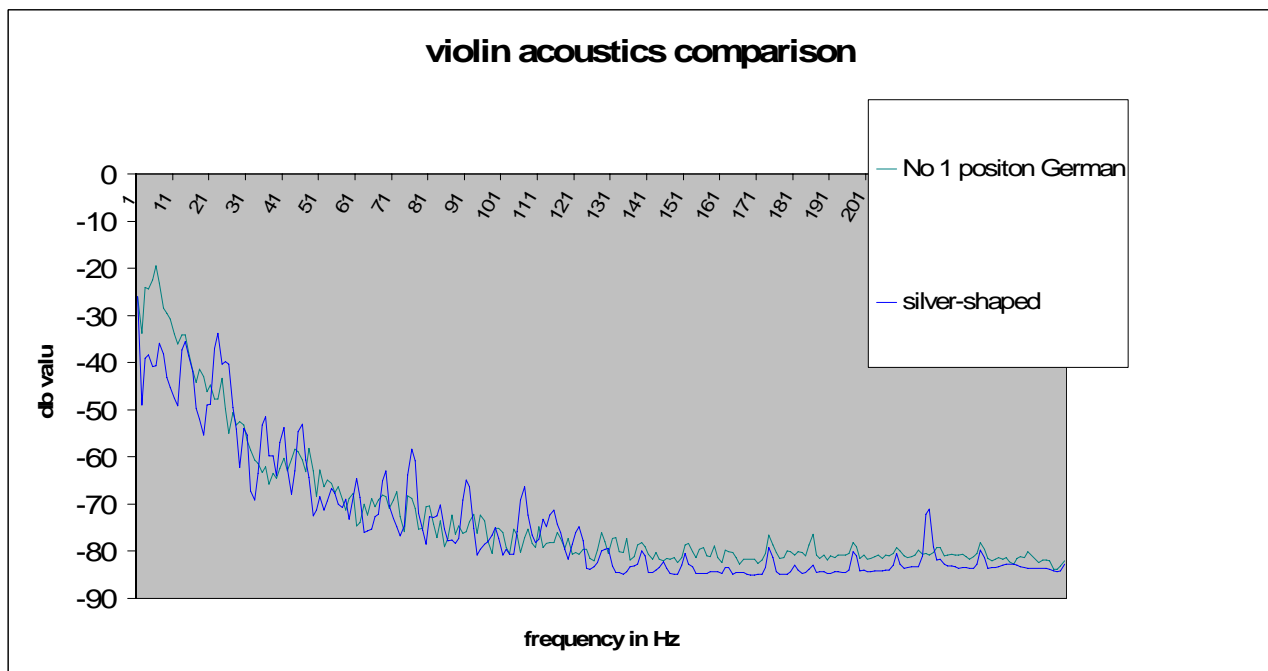
The trace labeled “No 1 position German” is the final position I achieved for the maple bridge and my sound sampling software analysis of my personal violin. Below is the same chart with the non-relevant traces suppressed. I left one “old master” trace for comparison. As you can see, the best sound I could achieve using a maple bridge is far better than the “silver – shaped” trace. Although throughout the entire spectrum the “silver – shaped” bridge “jumped all over”, it was far below the actual performance of the old school maple bridge. The trace was the best I could achieve with moving the bridge forward and back and still keeping it centered on the instrument. As you will notice in the lower frequencies, the lack of sound transmission was significant and with the slight exception of some occasional ‘peak’, was well below that of a well made maple bridge.

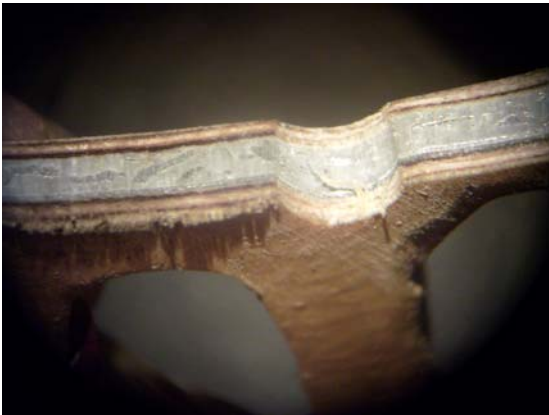
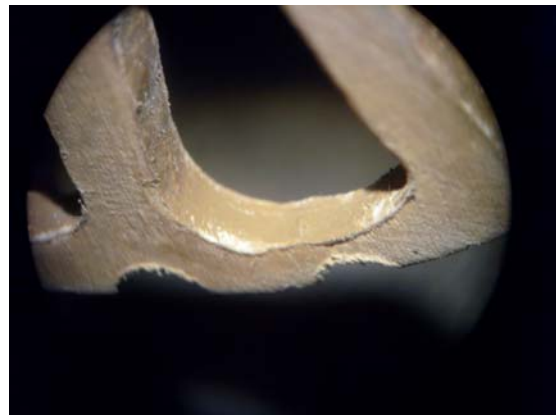
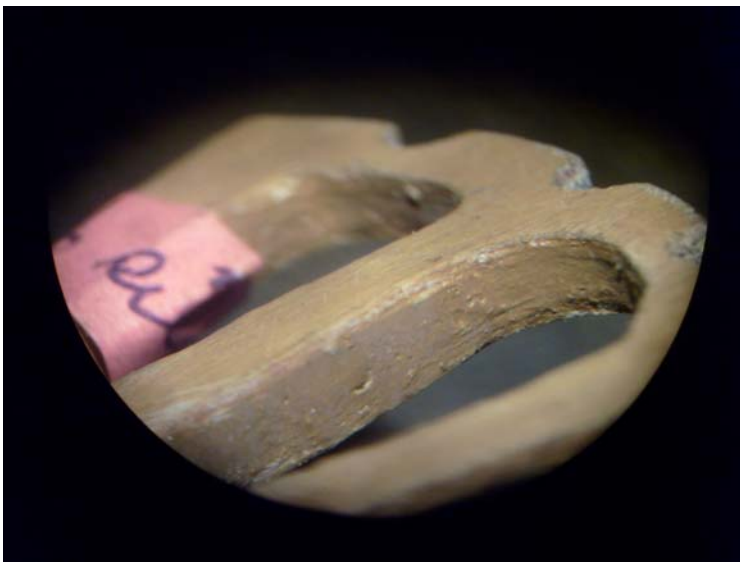
The inventor had sent 3 bridges for testing, but after examining them closer with a microscope, and then having such issues with the first one as scratching the violin severely, then the poor construction details, uneven surfaces, inconsistent openings, inconsistent mass, and poorly distributed flakes of silver colored metal particles in a resin mixture sandwiched between 2 small .042” thick plywood sheets, I chose to end this analysis since any data achieved beyond the initial plots shown above for initial curiosity would be meaningless in a controlled study except for that single one under study and the results will not apply to all bridges made by the inventor. Just because there’s a patent issued for a design, does not indicate an acceptable product per the claims.

The poor craftsmanship of all 3 of the samples would indicate a handmade and/or prototype appearance ...unworthy of retail sale at any cost. The inner surfaces were “painted by hand” with what I would suspect was an artists’ watercolor brush, the texture consistent with lumpy epoxy glue of tan color as show in the above photograph. This would also contribute to the lack of performance as suggested.

It is suggest that the designer look into the use of modern manufacturing techniques using laser, waterjet, and/or CNC processes and perhaps the use of molds and proper mixing machines to achieve a uniform recipe for the metallic/resin mixture and provide a method to prevent that metal compound from causing either string or instrument damage. The samples sent to me for analysis were exactly that... SAMPLES. In my opinion, without extensive tooling, assembly and packaging/marketing skills, this item is still in the prototype stage of development and is still a far ways from full retail production. If the use of modern manufacturing techniques and equipment were used and perhaps a professional facility, then the cost of manufacturing could easily be reduced to levels that will compete with current products. The estimated time to mfg one item in an assembly line environment can most likely approach a few minutes, instead of 2 hours as indicated by the inventor. The instruction sheet was poorly written, margins were minimal which made reading difficult and the font was all BOLD on the first and second pages with the use of all capital letters highlighting a ‘sales pitch’ style verbiage which lent no useful content to the ‘instructions’. Hand drawn sketches and the lack of photographs lent the air of ‘home made’ to the entire package and the lack of professional formatting also confirmed those suspicions.
