# Sound Analysis Report on the Comparison of the Schneider Violin Bridge to that of a hand carved and tuned Maple Bridge of Standard design and shape. By: Dennis Boring 04/2012

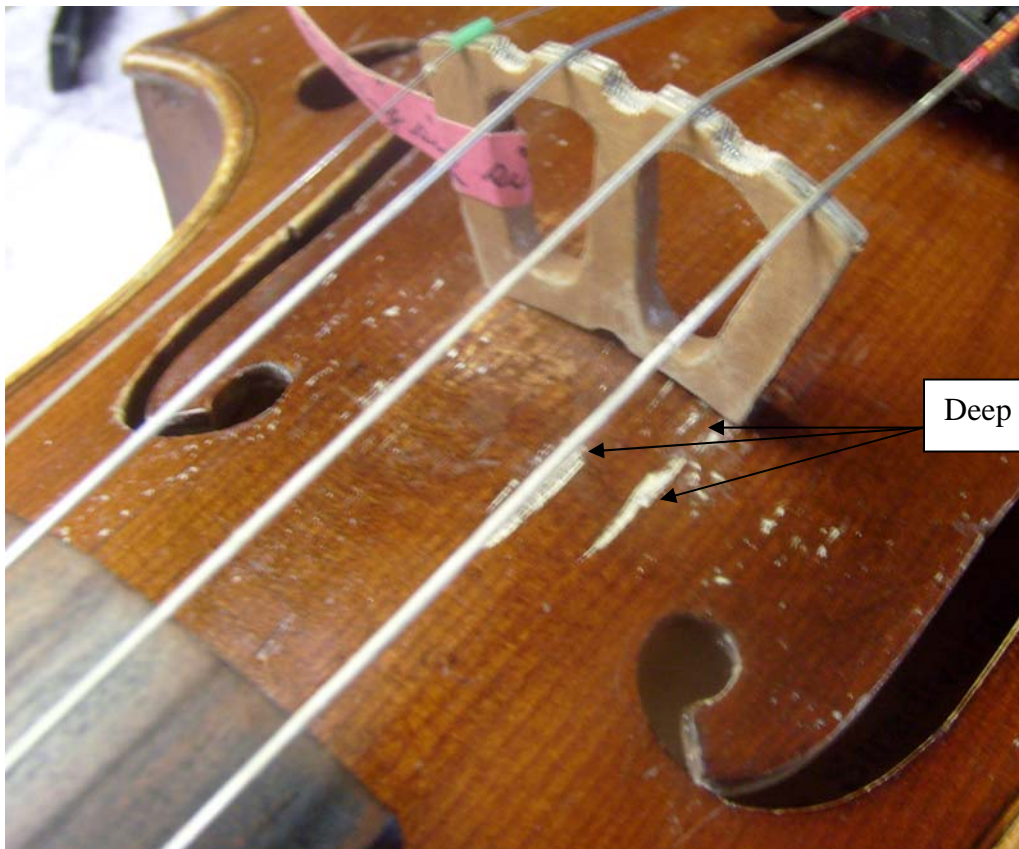
Although it is obvious this would have affected the mechanics of sound transmission, there would be no other way to install this bridge so it had to be done. In an attempt to install it in the same location of my existing bridge, I attempted to 'swing' it up into position and deeply scratched the surface of the body from the harsh metallic content within the laminate. After removing the bridge I was able to refinish the affected areas with a combination of the 'French polish' procedure and a tiny bit of oil varnish diluted with 180 proof alcohol AND will wait about 3 days for it to cure before final polishing and reinstalling of my original maple bridge. The instructions said the end user should mix up some epoxy, spread it on the bottom of the feet and allow it to cure, then shape it to fit... etc. which is a complex job even for a luthier to accomplish and would add to the already high cost of the product making it prohibitive for most customers to even consider, and besides, the bridge was too tall already, and adding anything would make it too tall to even function properly.
